Paper # MA-T5-02

**Pilot Tube Microtunneling Chosen in Omaha Nebraska
for 585', Single Drive with Depths Reaching 50'
to Preserve Sensitive Garden Area**

Case Study: Pilot Tube Microtunneling project: 30" Diameter Storm Sewer
Project: Lauritzen Gardens Sanitary and Storm Sewer Separation Project
Owner: City of Omaha, Nebraska
Engineer: HDR; Omaha, Nebraska
Contractor: Horizontal Boring & Tunneling Co.; Exeter, Nebraska

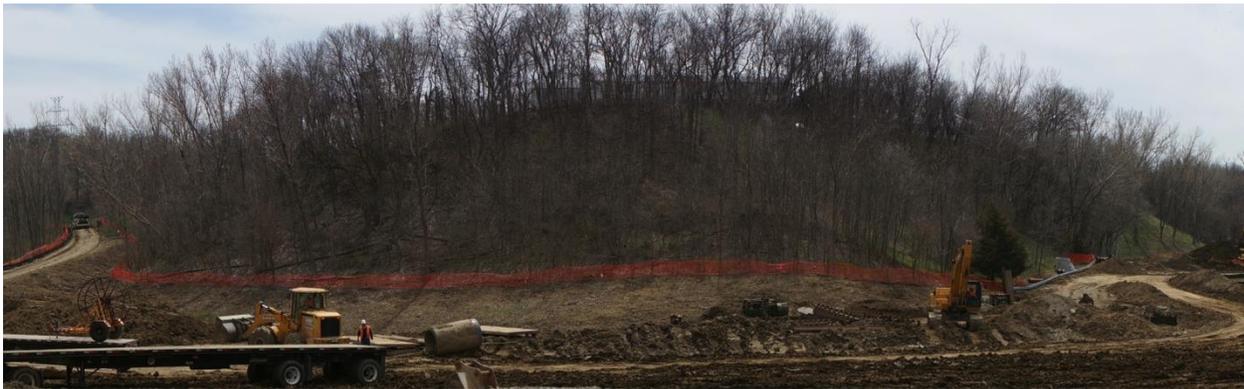
FIGURE 3: Tree-covered hill obstructed line of sight

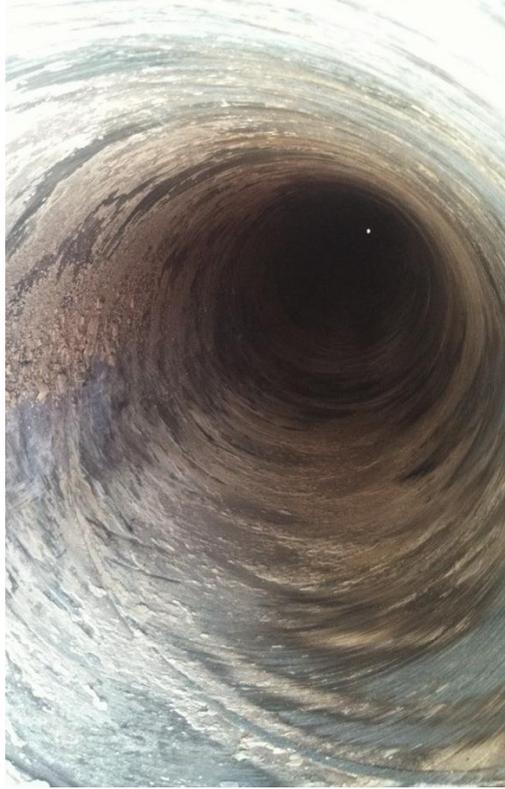
The harder than expected soils and stiffness of the welded casing string made the attempt to smooth the alignment at the intersect point problematic. When the 24" temporary casing reached the intersect point in the original pilot tube path, the auger began to bind against the casing, indicating the auger was following the pilot tube through the slight bend, while the casing was continuing in a straight line. In order to alleviate some of the pressure, a bit was inserted to provide greater overcut in an attempt to get the casing to follow the pilot tube alignment. Use of a rock bit did not alleviate the bind, and when the rock bit was removed, it was apparent the swivel between the auger and pilot tube had been destroyed. In order to get a 24" casing through the entire crossing, the augers were removed from this casing and moved to the other pit (on the downhill side) where a second auger boring machine was set up to drive the remaining length in the opposite direction. The casings didn't meet up as desired, so the 24" temporary casing string could not be tied together. The crew began to remove casing from the downhill shaft by pulling it out while the other string of casing was augered and pushed down through from the uphill shaft. The crew was able to periodically inspect the behavior of the 24" casing being pushed downward from inside of the 24" casing being pulled out. Using this push-pull technique, the crew was able to achieve a continuous 24" temporary casing through the entire run, although the bend was still present, daylight could be seen through the 24" casing (See Figure 7).

FIGURE 7: View through the 24" temporary casing

After careful consideration of the current conditions and goals for the project, the decision was made to push the 38½" casing with 36" auger from the uphill shaft downward, while pushing out the 24" temporary casing. In order to connect and center the 38 ½" casing on the 24" casing, Horizontal Boring & Tunneling Co.'s fabrication shop produced an inverted top hat that would go inside the 24" casing and accommodate a swivel that attached to the hex on the 36" auger. This resulted in a similar configuration as before, where the 36" auger was connected directly to the 24" temporary casing. A rock bit was used and the crew began to push casing. Again, the crew encountered grinding near the point of intersect and the swivel connection was destroyed. The crew entered the casing and removed the top hat connection allowing visual inspection of the alignment. The 38 ½" casing was having trouble making the slight bend. The crew resumed the push-pull technique by pulling 24" temporary casing out from the downhill side with one boring machine while pushing 38 ½" casing downhill from the topside. Periodic visual inspection indicated the 38½" casing was on grade, but deviated from alignment. This deviation worsened in the softer soils towards the end of the crossing, but since grade was holding true, the crew continued to push. Once the casing emerged, the result was that the downstream end of the drive was out of alignment by approximately 3', with most of the alignment deviation occurring on the downhill end of the crossing in the softer soils.

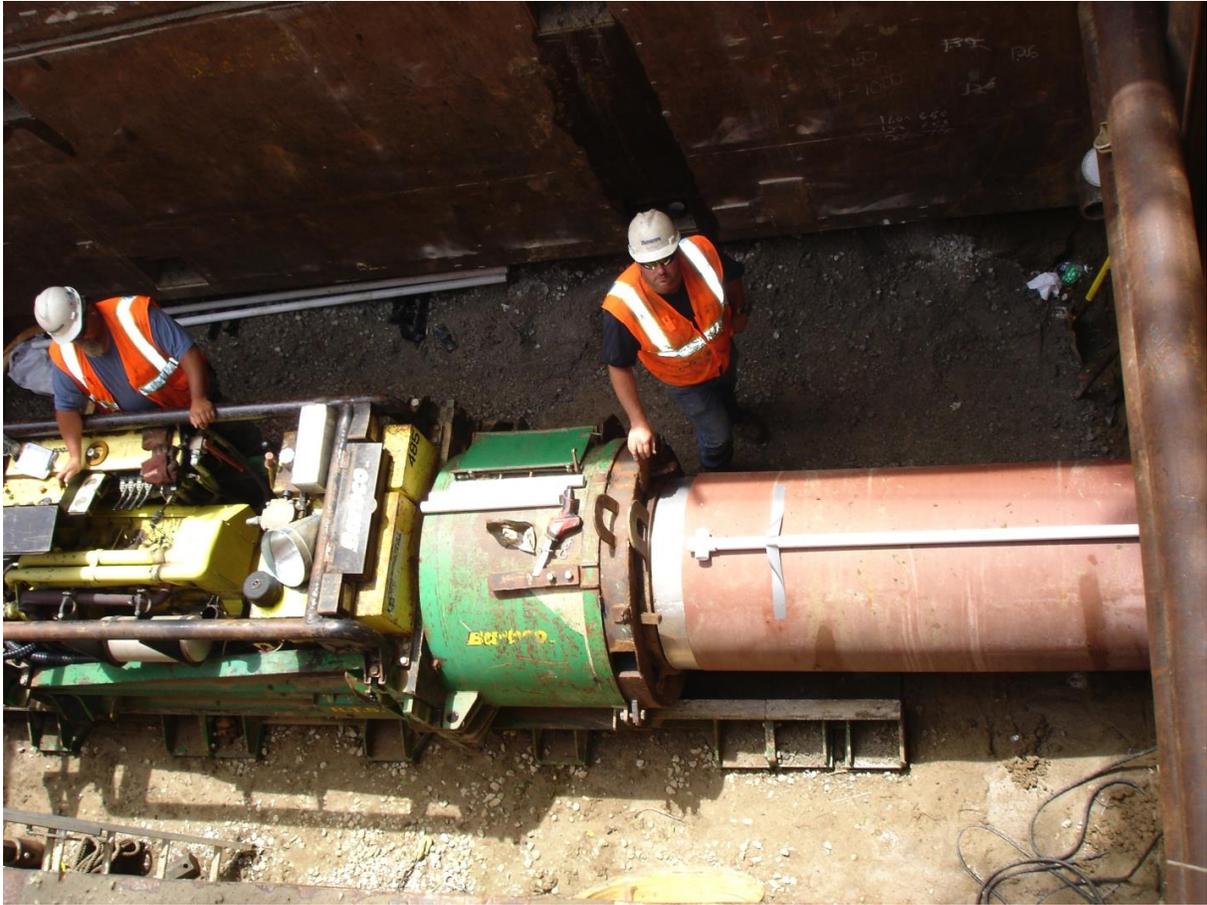
FIGURE 8: Jacking the 30" VCP in the final step became the smoothest part of the installation

With the path established by the 38.5" temporary casing, VCP was used to jack the casings out of the tunnel. The crew attached a 2" PVC line on top of the VCP in order to convey CLSM (Controlled Low-Strength Material) or flowable fill to fill the annular space at the completion of the installation (See figures 8 and 9). Some bentonite lubrication was used during VCP installation, but with an established alignment and hard clay soils, this became the smoothest portion of the project and was completed in just two days.

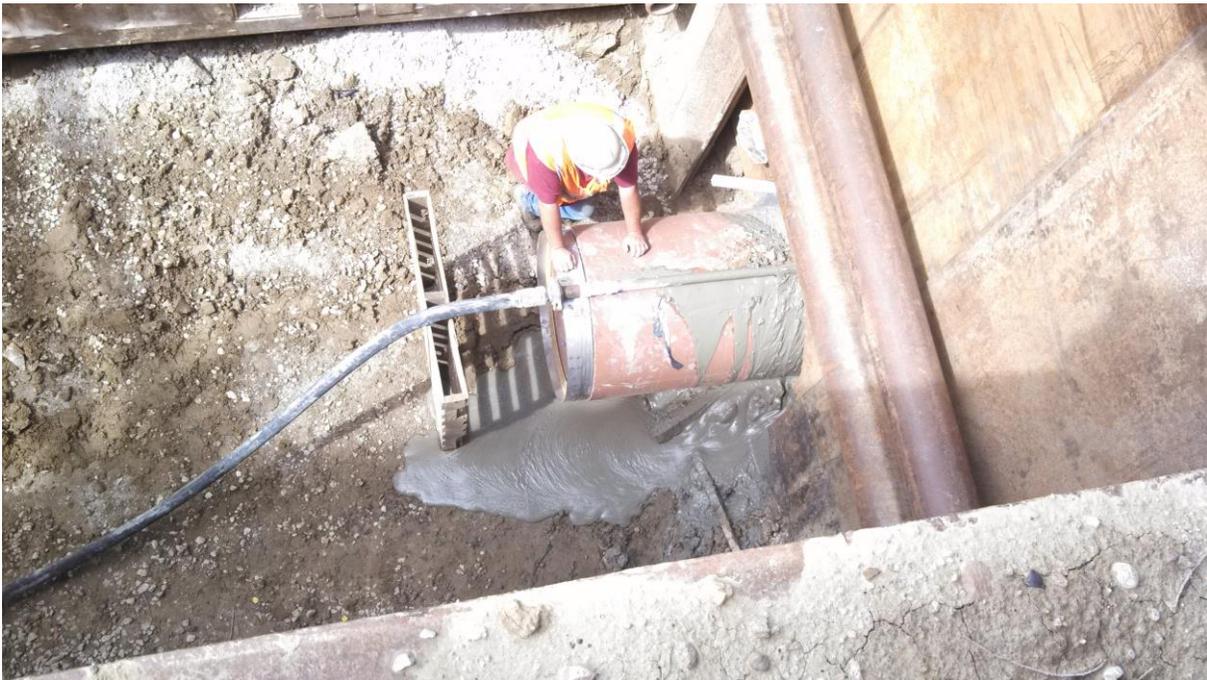
FIGURE 9: Pumping CLSM to fill the annular overcut
