The Lauritzen Gardens Project

Preserving a Sensitive Area with a 585-Foot Single Drive at Depths Reaching 50 Feet

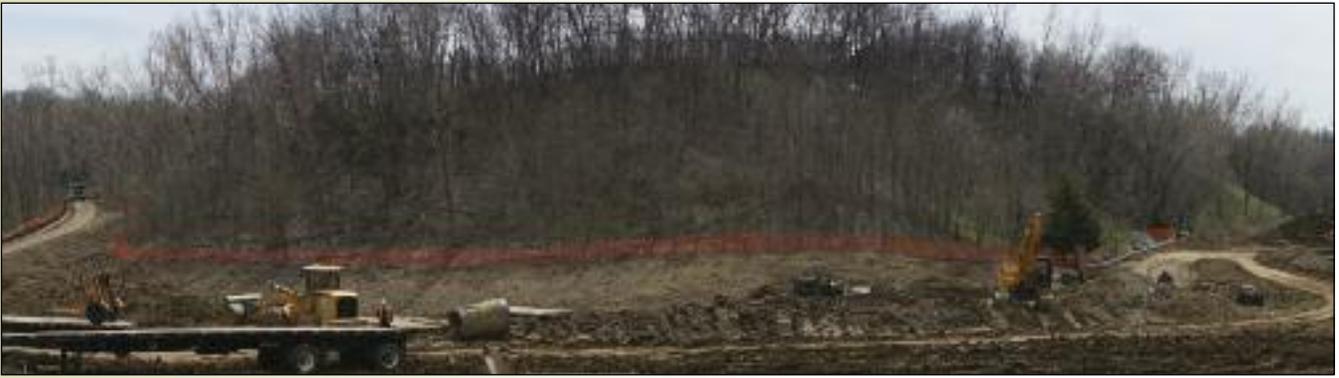
A tree-covered hill obstructed the line of sight.
